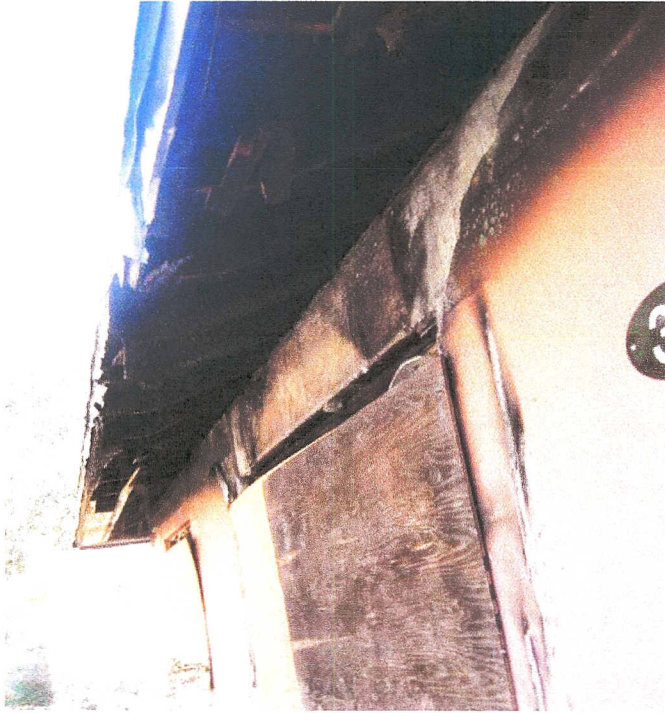
IMG_4302: More severe fire damage noted at soffit framing.

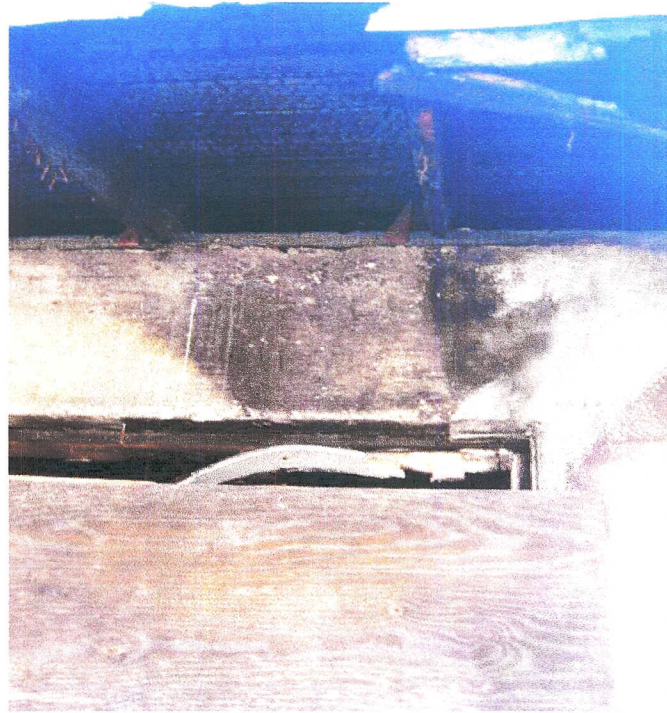
IMG_4303: Roof deck severely damaged.

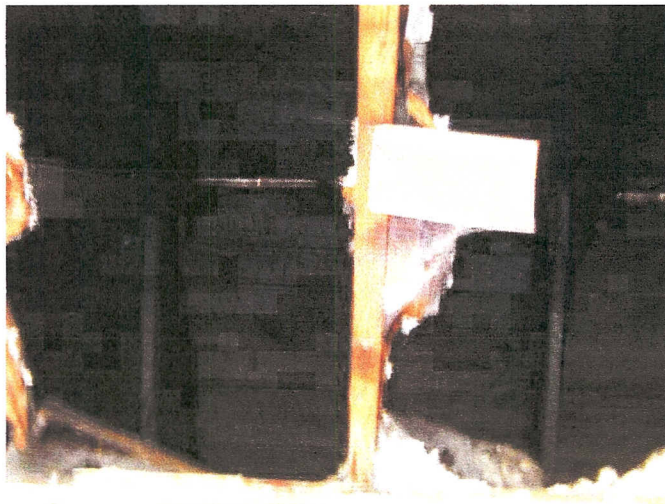
IMG_4304: Severely damaged trusses & roof deck.

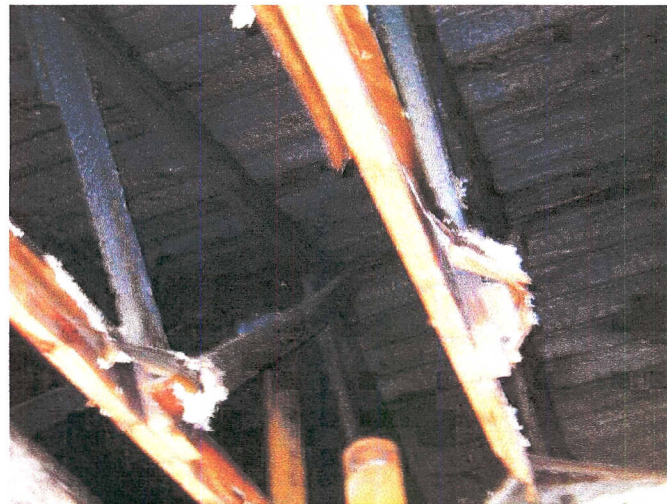
IMG_4305: Severely damaged trusses & roof deck.

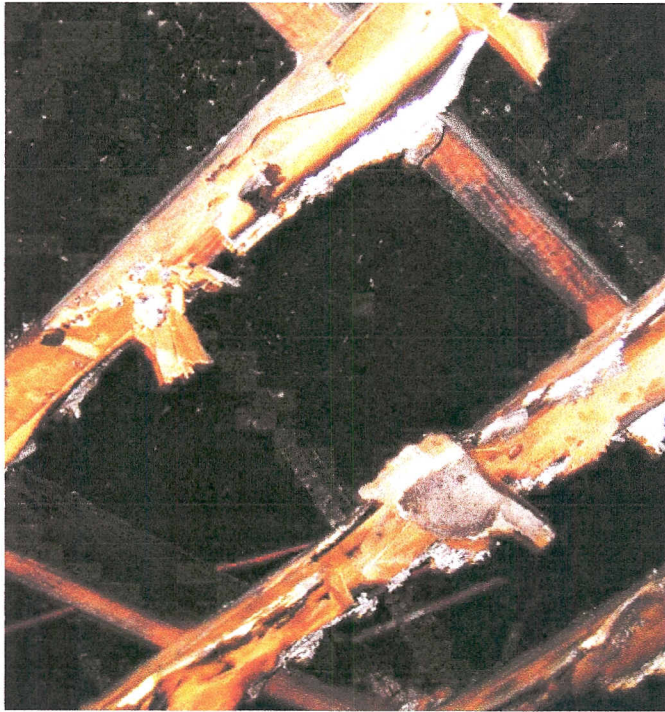
IMG_4306: Severe damage to trusses & deck.

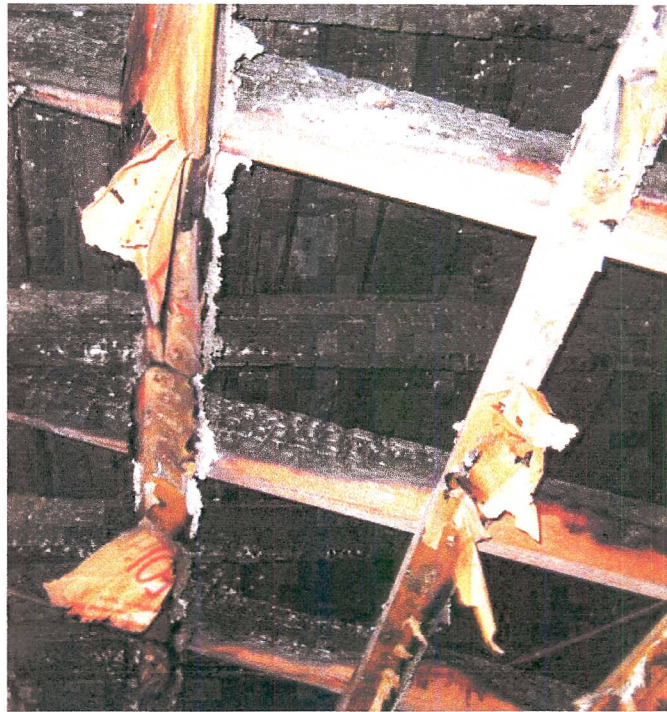
IMG_4307: Sever damage to trusses & deck.

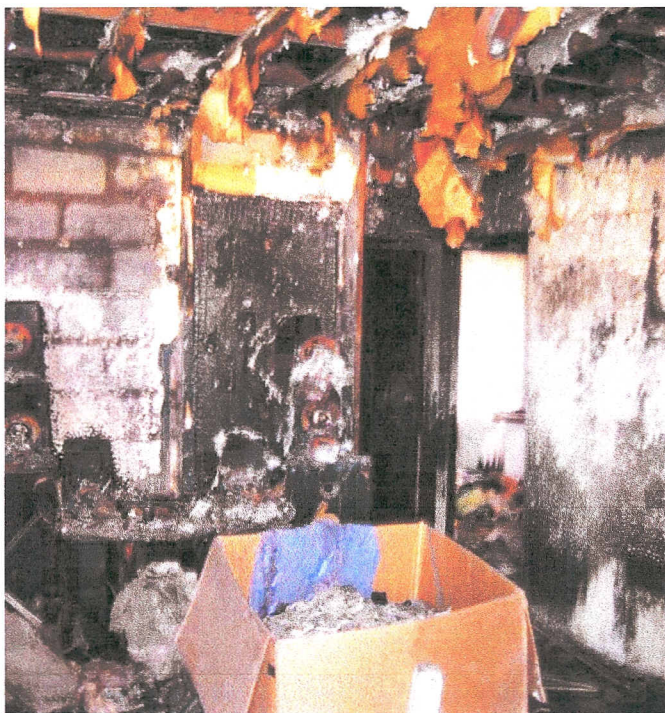
IMG_4308: Overview of interior damage.

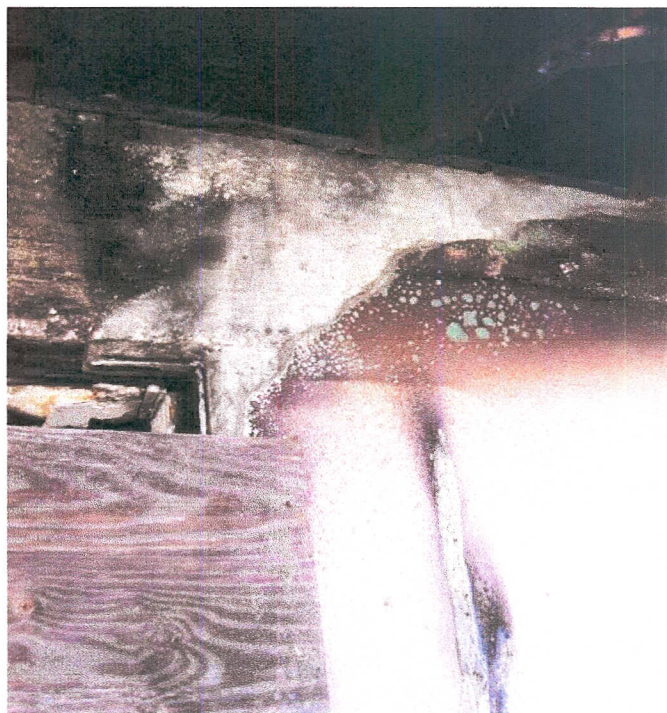
IMG_4309: Stucco finish broken away at roof tie beam. Concrete beam extends over window.

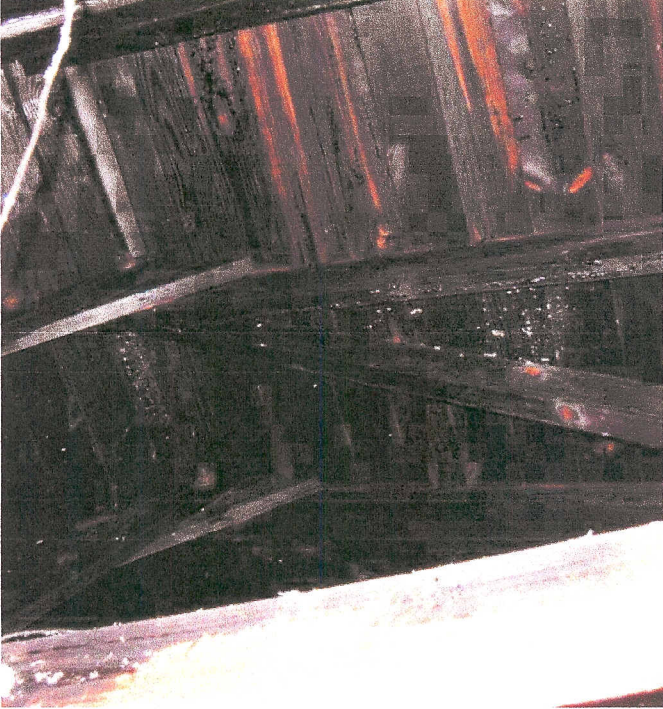
IMG_4318: Moderate damage to trusses and decking at this location.

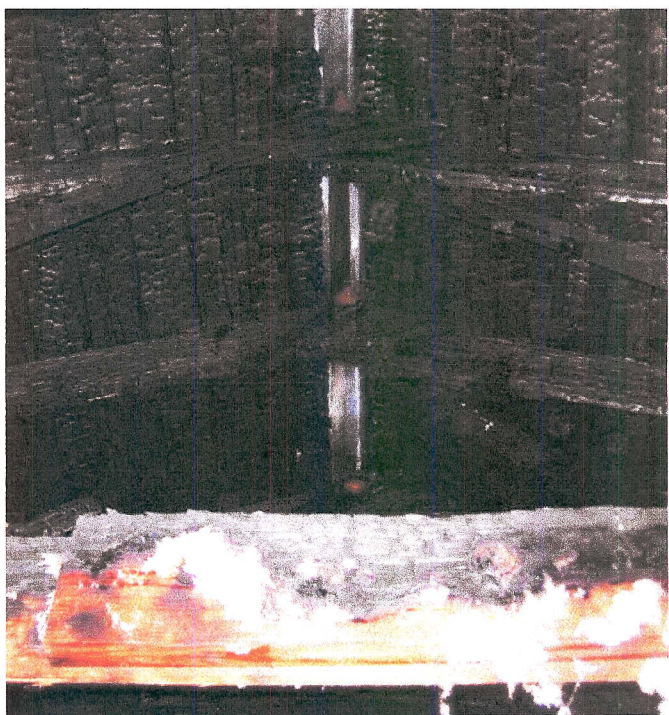
IMG_4323: Severe truss and deck damage at this location.

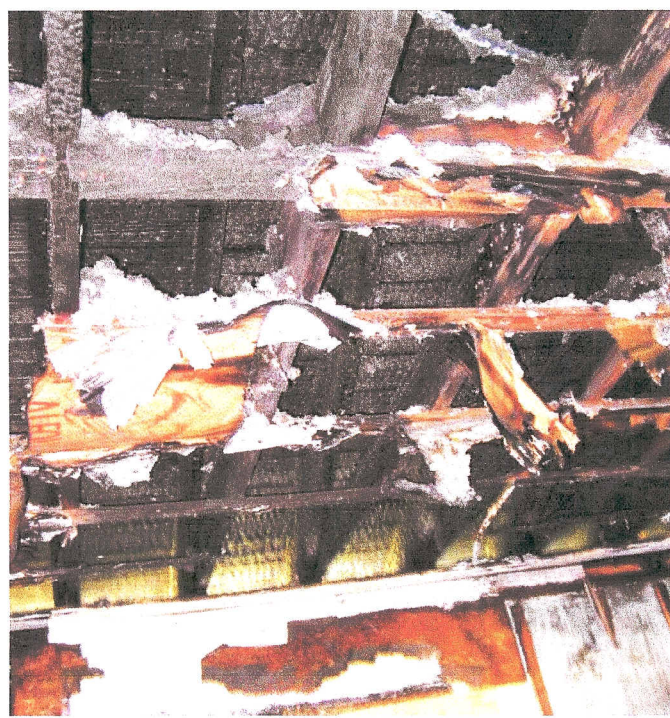
IMG_4324: Severe damage to trusses & deck.

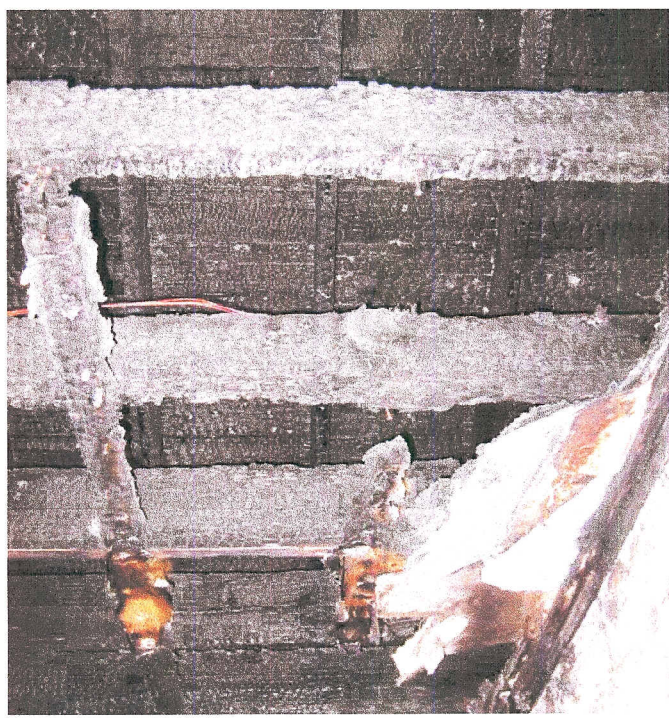
IMG_4325: Severe damage to trusses & deck.
