IMG_4274: Units #33 & #34 - overview of building perimeter

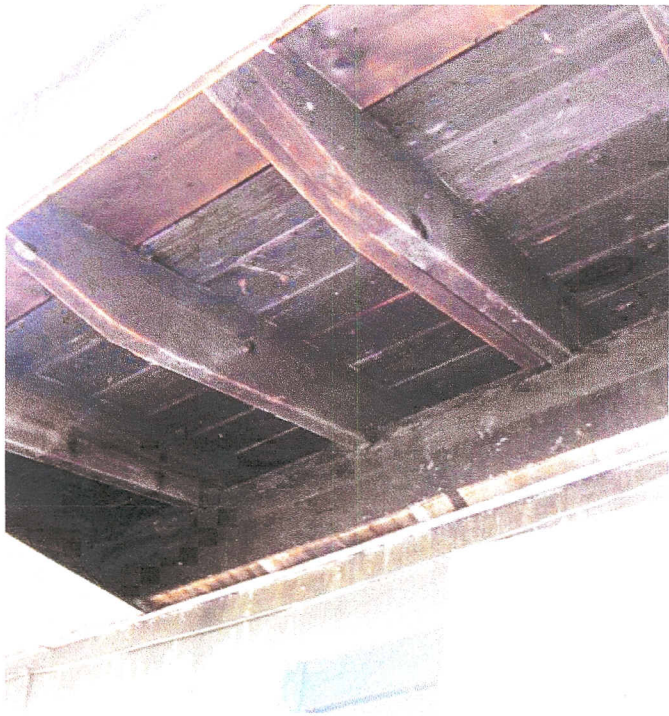
IMG_4278: Smoke damage at soffit.

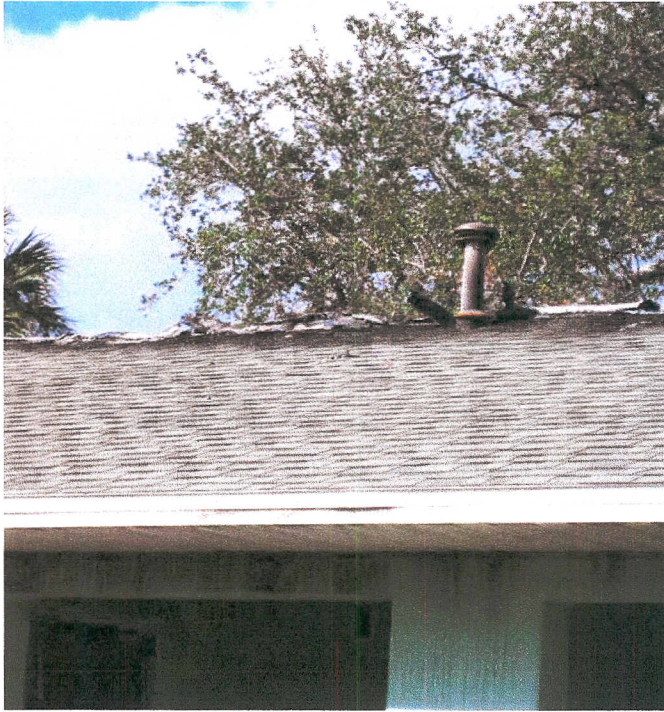
IMG_4282: Fire burn-thru at roof.

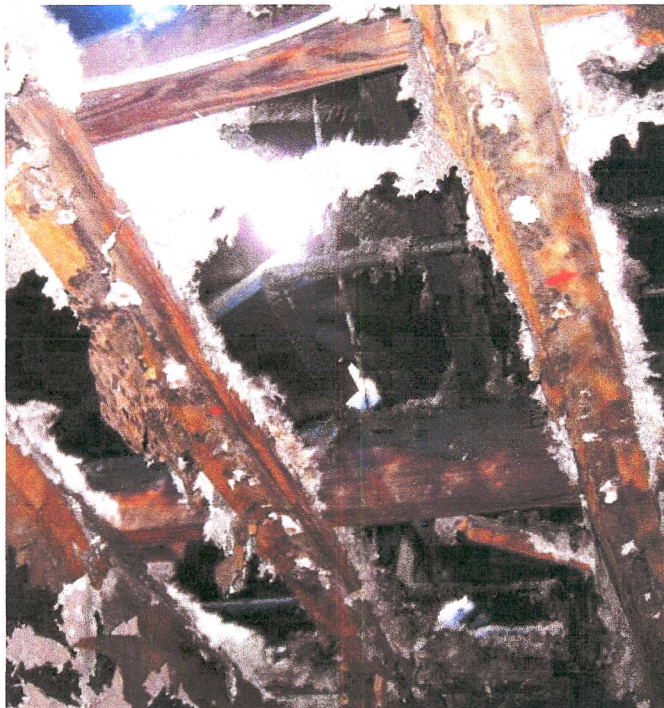
IMG_4284: Ceiling framing to bottom of roof trusses. Trusses are badly burned above.

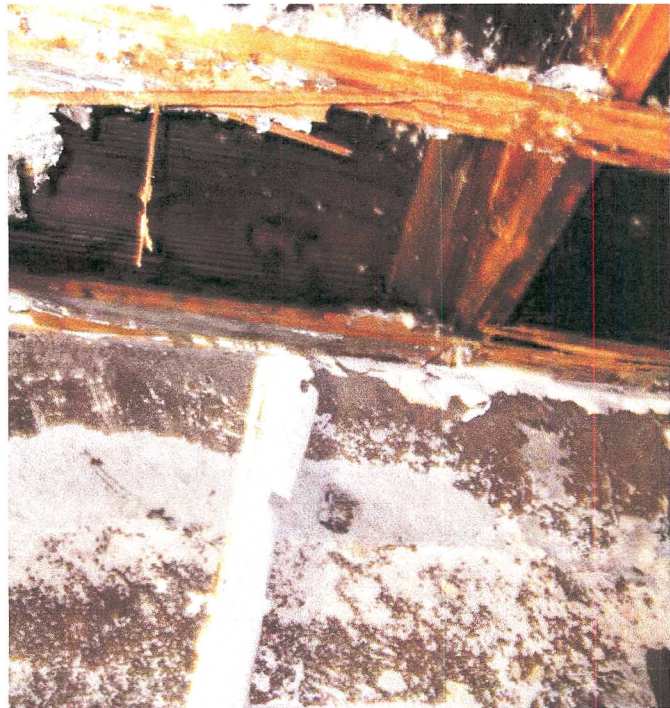
IMG_4285: Truss bearing at perimeter wall.

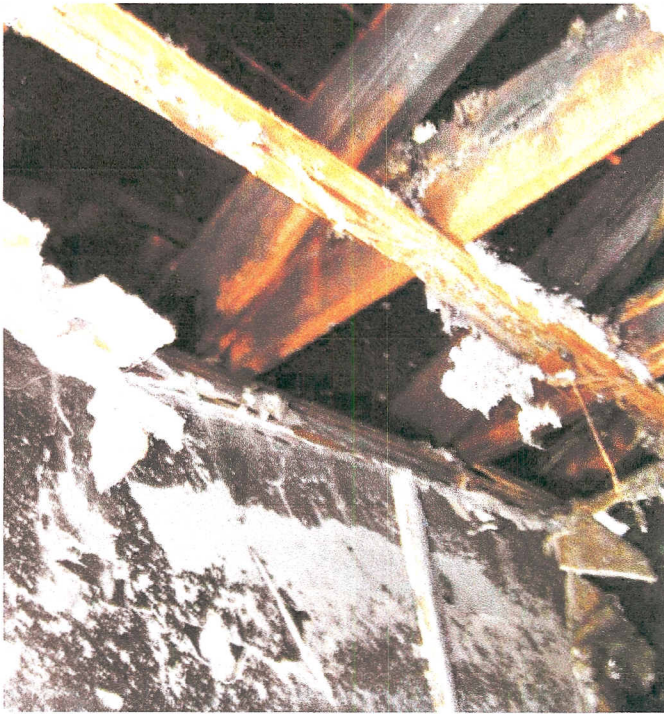
IMG_4286: Smoke damage at truss bearing wall.

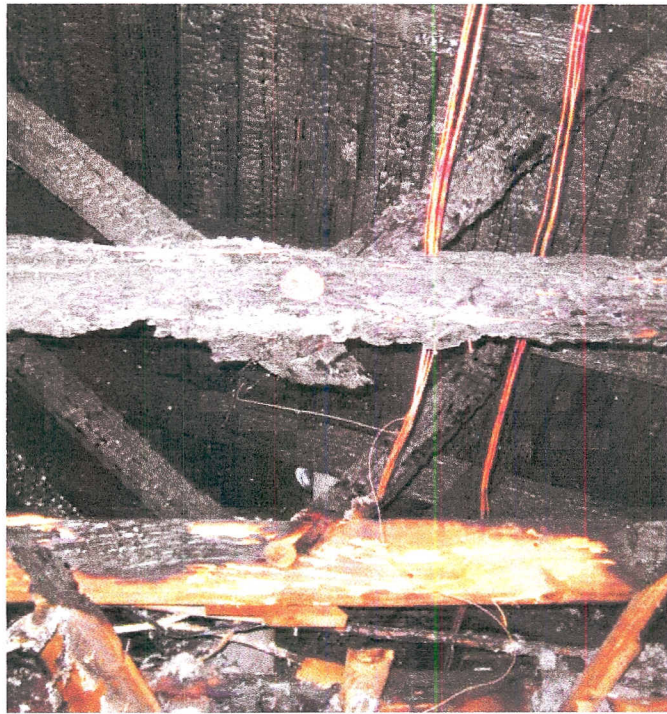
IMG_4287: Trusses and roof deck is severely damaged by fire.

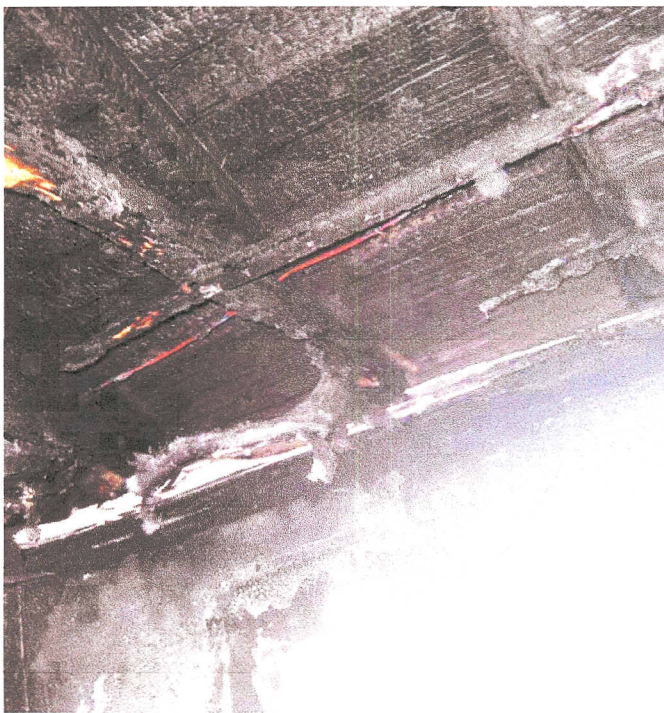
IMG_4288: Severe truss damage.

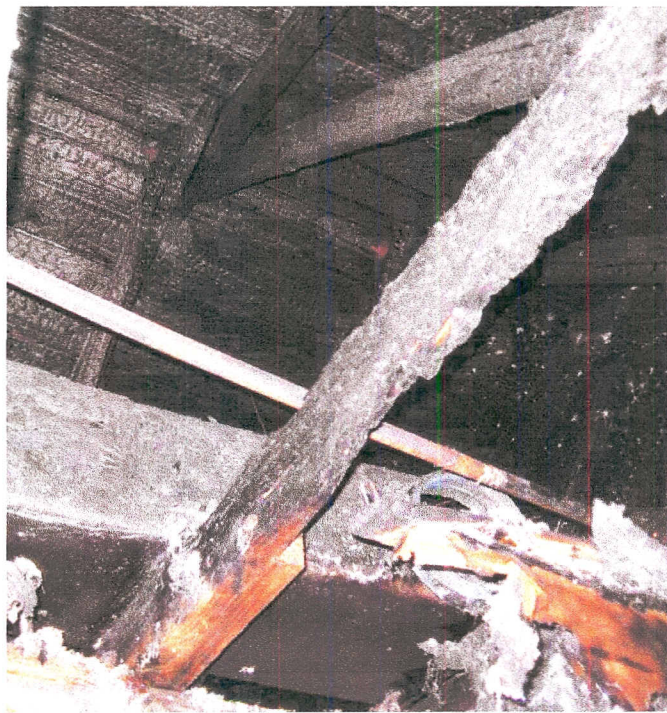
IMG_4289: Severe truss damage.

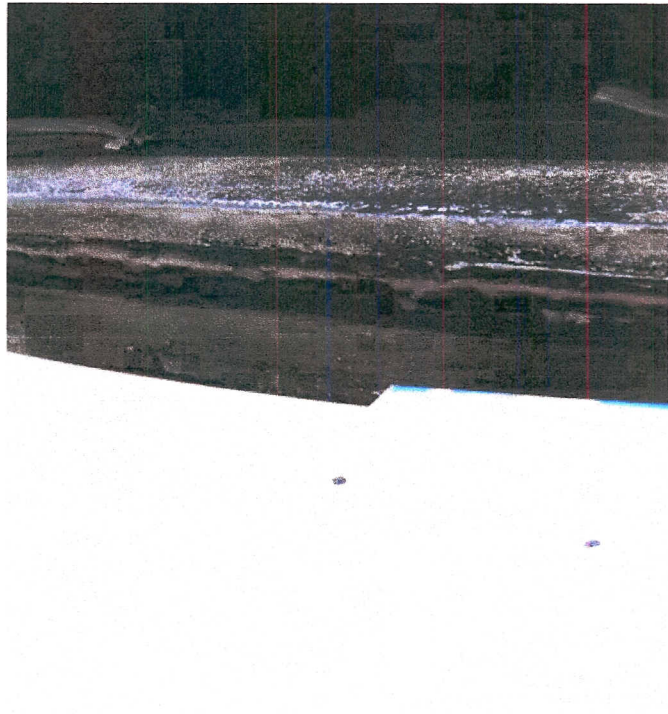
IMG_4291: Melted window frame at bottom of lintel.

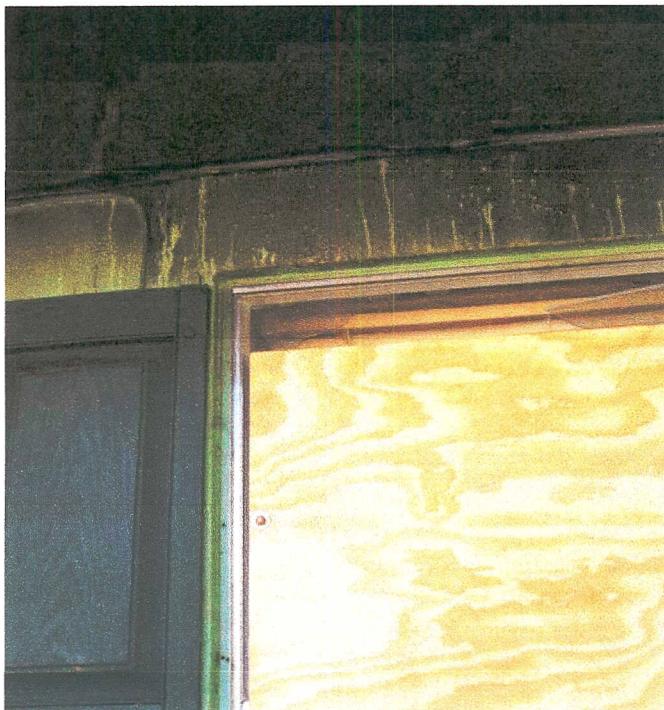
IMG_4292: Top of window opening.

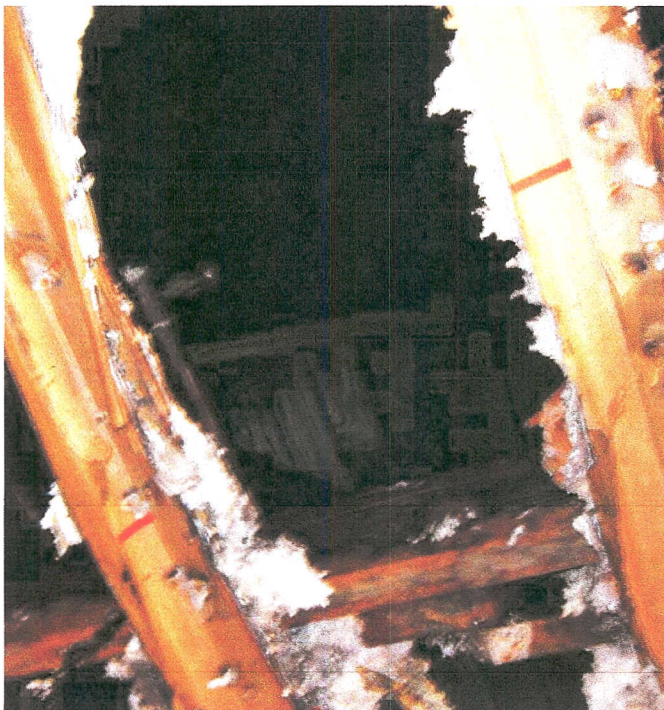
IMG_4300: Moderate damage to truss and deck at this location.
